Apr 30th, 2025

302 Prairie View Court, San Jose, CA 95127

# Home Inspection Report

Caleb Zhang / Nextgen Home Inspections,  
LLC

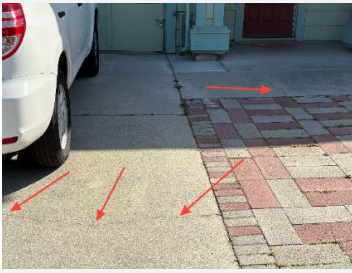
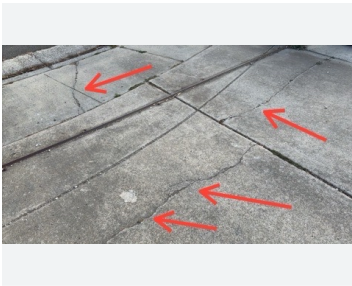
Location - Southwest

#### Driveway cracks

The driveway has noticeable cracks, which may result from age, settling, or weather conditions. Recommend sealing the cracks to prevent further deterioration and potential water damage. Consider consulting a profes-

sional for repairs if the cracks expand or deepen over time. Regular maintenance can extend the driveway's lifespan.

Typical cracking noted

Recommend sealing crack(s) and resurfacing as needed

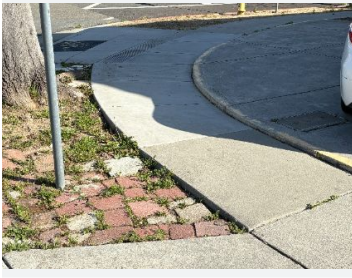
Location - West, Southwest

**sidewalk trip hazard**

During the inspection, a trip hazard was observed on the sidewalk due to uneven concrete slabs. This poses a safety risk to pedestrians. It is recommended to have a qualified contractor assess and repair the uneven sections to ensure a smooth and safe walking surface. Additionally, regular maintenance checks are advised to prevent future hazards.

Crack(s) and uneven areas. Recommend repairs to create safe walks.

Recommend that a qualified contractor evaluate and estimate repairs

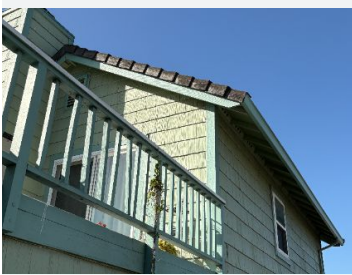
**Recommend painting/caulking wood finish**

The wood finish on the exterior soffits and fascia shows signs of wear and deterioration. It is recommended to repaint and apply fresh caulking to protect against moisture intrusion and potential damage. Regular maintenance will extend the lifespan and maintain the aesthetic appeal of these areas. Consider hiring a professional painter for optimal results.

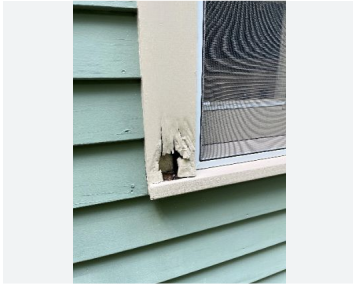
Location - Eastside wall

The exterior window trim shows signs of rot, which can lead to further deterioration and potential moisture intrusion. It's important to repair or replace the affected trim to prevent damage to the underlying structure. I recommend consulting a qualified contractor for evaluation and repairs. Regular maintenance will help extend the life of the windows.

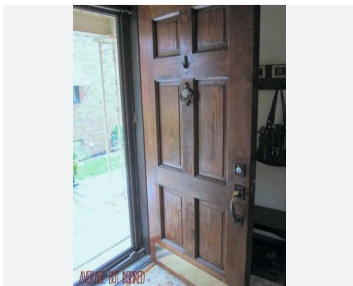
Location - Southwest

The front exterior door shows significant signs of weathering, with noticeable sun damage, cracks, and faded paint. Additionally, both the door seal and weatherstrip are broken or damaged. It is recommended to sand and repaint the door to restore its appearance and protect it from further weather damage. Also, replacing the seal and weatherstrip will ensure optimal energy efficiency and weather resistance. Consider consulting a professional for these repairs to maintain the door's integrity and functionality.

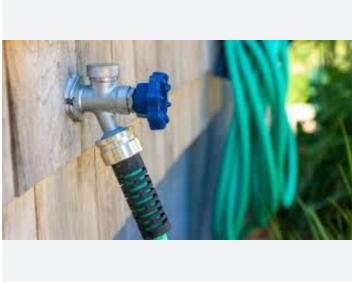
Location - Southwest

The exterior hose bib was observed to be dripping water, which can lead to water wastage and potential damage to surrounding areas. It's recommended to have the hose bib inspected and repaired by a qualified plumber to prevent further leakage and ensure efficient water use.

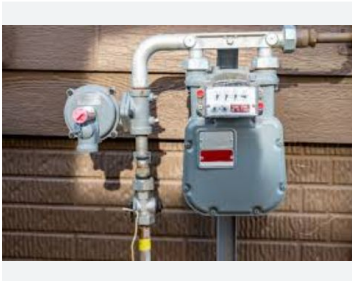
**Gas meter has some rust and need to keep it clean**

During the inspection, rust was observed on the exterior gas meter. It is important to keep the gas meter clean and free from rust to ensure proper operation and to prevent potential damage. It is recommended to clean the meter gently using a wire brush and apply a protective coating to prevent further rust. If rust persists or if there are concerns about the gas meter's functionality, consult with a professional for a more thorough evaluation and maintenance.

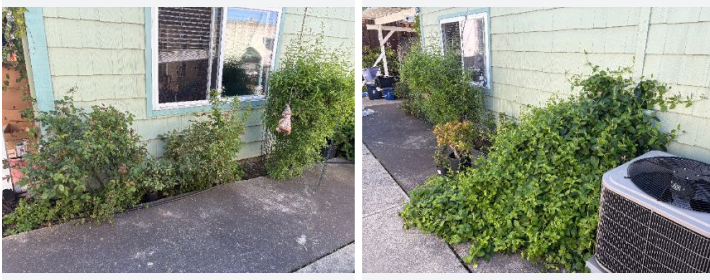
**Vegetations are too close to the building**

The vegetation is observed to be too close to the building, which can lead to moisture retention, pest intrusion, and potential damage to the siding or foundation. It is recommended to trim back or remove plants to maintain at least 12-18 inches of clearance from the exterior walls. This will help improve air circulation, reduce moisture buildup, and minimize pest risks. Reassess the plant growth periodically to ensure compliance with safe clearance distances.

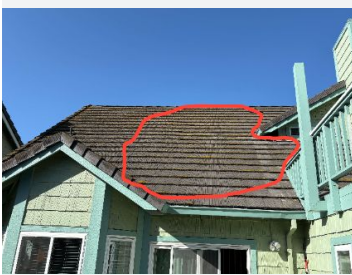
#### Mold Grow on Roof

During the inspection, mold growth was observed on the roof. This indicates moisture buildup, which could lead to structural damage if not addressed promptly. It's recommended to conduct a thorough cleaning and inspect for potential sources of moisture. Consider consulting a professional roofer or mold remediation specialist to assess and rectify the underlying issue to prevent further damage. Regular maintenance and improved ventilation may also help in preventing future mold growth.

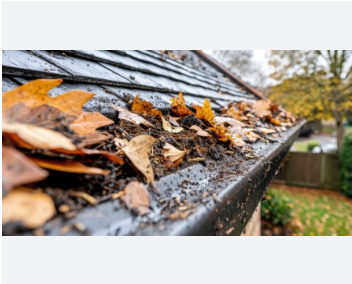
Location - Along all eaves

Need cleaning

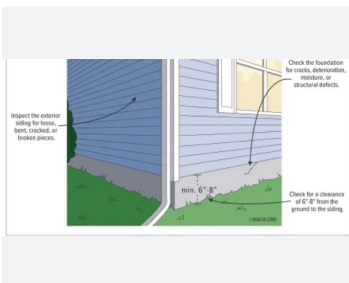
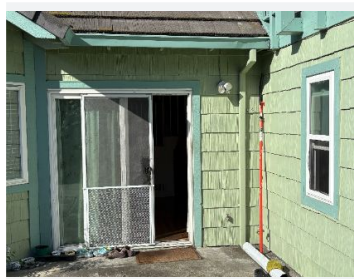
Down spout has extension but grade is shallow

The exterior reveals critical concerns regarding the downspout and siding conditions. The downspout, visible near the sliding glass door, exhibits a shallow grade, failing to direct water effectively away from the foundation, which may contribute to moisture accumulation and potential foundation damage as noted in prior reports. Additionally, the siding shows direct contact with the concrete patio slab, increasing the risk of water infiltration and rot, particularly at the base where no clearance is apparent. Immediate action is recommended to extend and re-grade the downspout to discharge water at least 5 feet from the foundation, and to install a moisture barrier or elevate the siding to prevent prolonged contact with the concrete, ensuring long-term structural integrity.

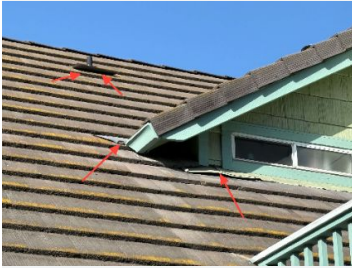
**COMMENTS:****Roof vents flashing uplifted prone to water intrusion**

During the inspection of the roof flashing, it was observed that the roof vent flashings are uplifted, which can lead to water intrusion. It is recommended to have a qualified roofing contractor evaluate and secure the flashings to prevent potential water damage. Prompt attention to this issue will help maintain the integrity of the roof and prevent further complications.

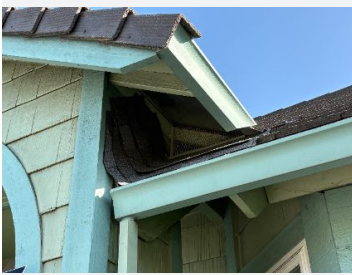
**Valley area leaks**

During the inspection, active leaks were observed in the roof valleys. These issues can lead to significant water damage and should be addressed promptly. I recommend having a licensed roofing contractor evaluate and repair the affected areas to prevent further deterioration and ensure proper water drainage. Regular maintenance checks can also help in early detection and prevention of future leaks.

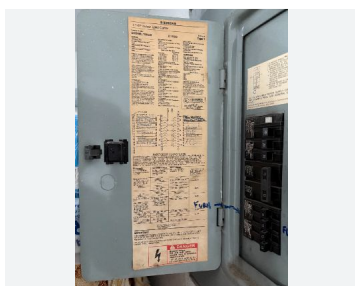
**Location** - Inside the converted garage

#### Main panel labels unclear

The dead panel was not removed and the electrical main panel labels were unclear and difficult to read, which may lead to confusion or delay in isolating circuits during maintenance or emergencies. It is recommended to have a qualified electrician relabel the panel with clear, accurate, and legible identifiers for each circuit. This will ensure safety and ease of use for future reference.

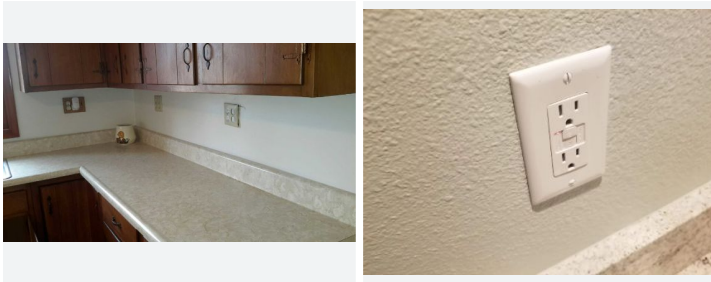
## GFCI was loose

Two of the GFCI outlet was found to be loose and one reversed its polarity during the inspection. This condition may lead to poor electrical connections and poses a potential safety hazard. It is recommended to have the outlet securely mounted and re-evaluated by a licensed electrician to ensure proper functionality and safety.

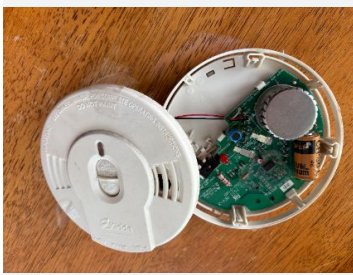
### Smoke Detector Missing or Out of Order

During the inspection, it was noted that the smoke detector was hanging loose in the kitchen and has no battery. It is vital to ensure the presence and proper operation of smoke detectors for early fire detection and safety. I recommend immediate replacement or repair of any non-operational units and installation where missing. Regular testing and maintenance, as per manufacturer guidelines, are essential to ensure ongoing functionality. Safety code requires installing smoke detectors outside each sleeping area, and on every level of the home.

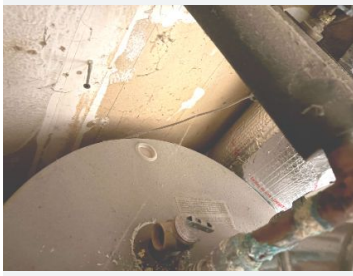
**Location** - Behind the heater exhaust

During the inspection, it was noted that the Pressure Temperature Relief (PTR) valve on the water heater has limited access, which can hinder regular maintenance and safety checks. Additionally, there is no discharge pipe attached to the PTR valve. It is recommended to have a qualified plumber evaluate and address these issues to ensure compliance with safety standards and proper functioning of the water heater system.

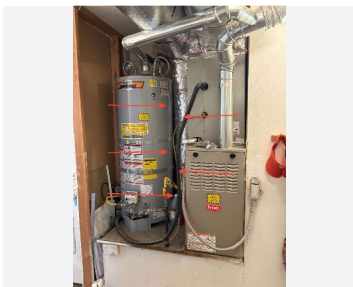
### Water Heater Close to Furnace

The heating and water heating systems at 3668 El Grande Drive, San Jose, CA, exhibit several major defects that require immediate attention. The furnace (Bryant model) and water heater (ProLine model) are installed in close proximity within a confined utility space, compromising the availability of adequate combustion air for both units, which poses a significant safety hazard due to potential carbon monoxide buildup. The temperature-pressure relief (TPR) valve on the water heater is improperly positioned behind the unit, rendering it inaccessible for maintenance and unable to function effectively in an emergency. Additionally, the absence of a drip pan beneath the water heater and a discharge pipe for the TPR valve increases the risk of water damage and scalding hazards. These critical issues necessitate immediate relocation of the units to ensure proper spacing and combustion air, installation of a drip pan, and correction of the TPR valve setup with a properly routed discharge pipe to comply with safety standards.

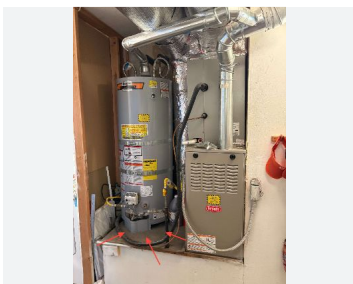
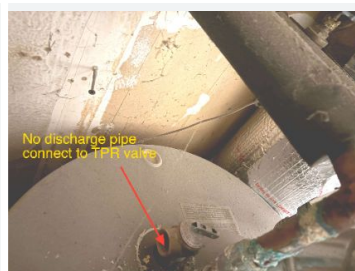
The water heater lacks a drip pan and TPR (Temperature Pressure Relief) discharge pipe. These components are essential for preventing water damage and safely controlling excess pressure and temperature. It is recommended to have a qualified plumber install a drip pan and TPR discharge pipe to meet safety standards and prevent potential hazards.

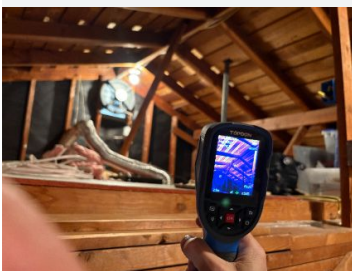
Possible moisture intrusion in attic near front door due to rain

During the attic inspection, thermal imaging revealed potential moisture intrusion, indicated by temperature anomalies. It is recommended to engage a licensed roofing contractor to assess the roof for leaks or water entry points. Prompt evaluation and remediation are advised to prevent structural damage or mold growth.

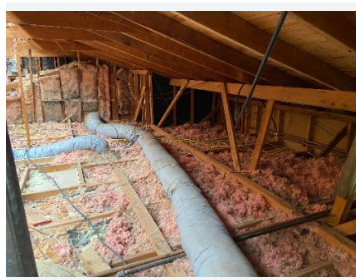
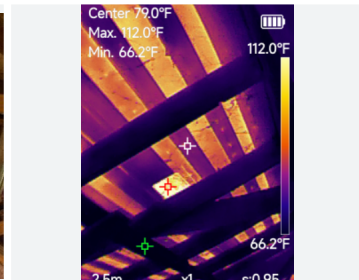
During the inspection of the attic insulation, cellular insulation was observed to be thin and unevenly distributed, with some areas having barely any coverage. Thermal imaging indicates significant energy loss in these sections. It is recommended to enhance the insulation to improve energy efficiency. A professional insulation contractor should be consulted to assess and properly address these deficiencies, ensuring even and sufficient coverage throughout the attic space.

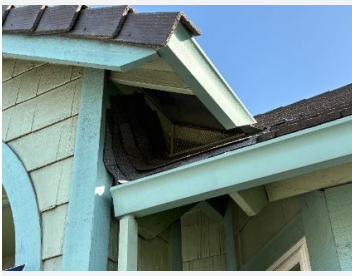
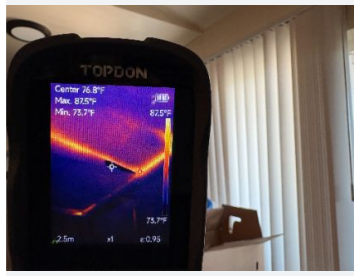
Possible moisture intrusion

During the inspection, thermal imaging indicated possible moisture intrusion in the attic, likely due to a roof valley leak. This can lead to structural damage and mold growth if not addressed. I recommend consulting a licensed roofing contractor to evaluate and repair the affected area promptly to prevent further damage.

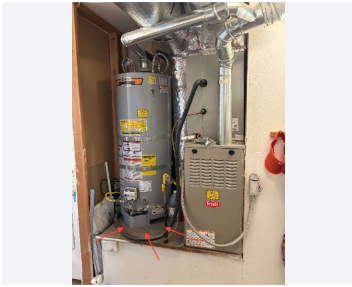
During inspection, it was noted that the furnace is located too close to the water heater. Both appliances require adequate combustion air to function safely and efficiently. Additionally, they should not share the same exhaust vent system, as this can lead to backdrafting and potential exposure to harmful gases. It is recommended to consult a licensed HVAC professional to assess the setup and make necessary adjustments to ensure compliance with safety standards and to prevent any hazardous conditions.

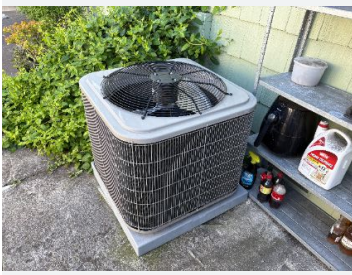
The air conditioning unit operates normally; however, it is surrounded by vegetation, which can impede airflow and reduce efficiency. It is recommended to trim back any nearby plants and ensure there is at least two feet of clear space around the unit. This will help maintain optimal performance and extend the unit's lifespan. Regular maintenance and clearing of debris is advised to prevent future issues.

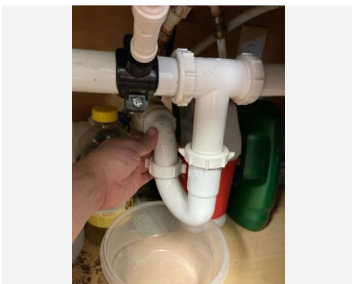
Location - Under kitchen sink

### P Trap leak under the sink

During the inspection of the kitchen plumbing/fixtures, a leak was observed at the P-trap beneath the sink. This issue can lead to water damage or mold if not addressed promptly. It is recommended to have a licensed plumber evaluate and repair the P-trap to prevent further complications. Regular maintenance is advised to ensure the plumbing system remains in good condition.

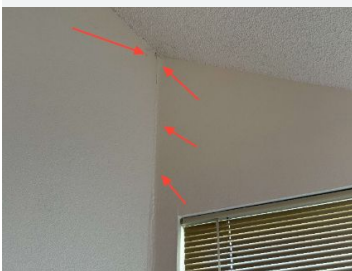
**Typical minor crack near ceiling wall**

During the inspection, a typical minor crack was observed near the ceiling-wall junction. This is generally due to normal settling of the structure. It is recommended to monitor the crack over time for any changes. If it worsens, consult a professional to assess and address any underlying issues. Regular maintenance and periodic inspections can help ensure the integrity of the ceiling.

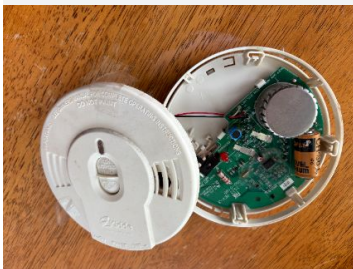
Location - Should be at the kitchen ceiling

### Smoke Detector Missing or Out of Order

Missing/low battery

During the inspection, it was noted that the smoke detector is either missing or not operational. This is a significant safety concern, as functional smoke detectors are crucial for early fire detection and occupant safety. It is recommended to install and/or replace smoke detectors immediately. Ensure they are positioned according to local codes and test them regularly to confirm proper operation. Consider using detectors with a 10-year lithium battery or those integrated into a monitoring system for enhanced safety.

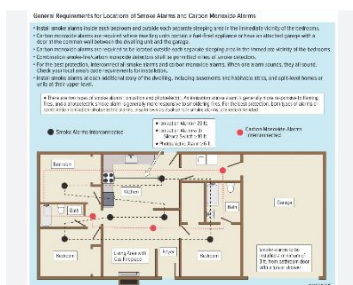
Location - Entirely missing

## Missing Carbon Monoxide Detector

### Missing/Low battery

It was observed that there is a missing carbon monoxide detector. It is crucial to install a carbon monoxide detector on each level of the home and near sleeping areas to ensure safety. I recommend installing UL-listed detectors promptly. Regularly test them and replace batteries as needed.

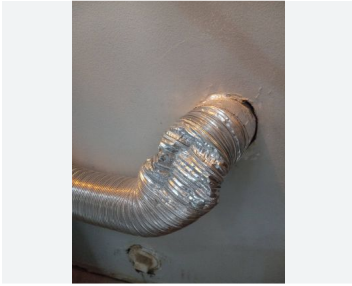
During the inspection, the dryer exhaust hose was found to be crushed. This can restrict airflow, potentially leading to inefficient dryer operation, longer drying times, and an increased risk of overheating or fire. It is recommended to replace the damaged hose with a rigid or semi-rigid duct to ensure proper ventilation and

enhance safety. Regularly inspecting and cleaning the vent system is also advised to maintain optimal dryer performance.

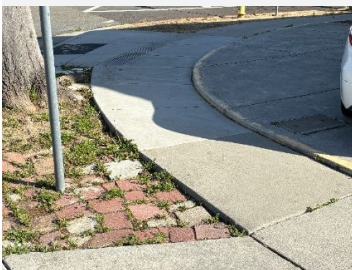
Location - West, Southwest

#### sidewalk trip hazard

During the inspection, a trip hazard was observed on the sidewalk due to uneven concrete slabs. This poses a safety risk to pedestrians. It is recommended to have a qualified contractor assess and repair the uneven sections to ensure a smooth and safe walking surface. Additionally, regular maintenance checks are advised to prevent future hazards.

Crack(s) and uneven areas. Recommend repairs to create safe walks.

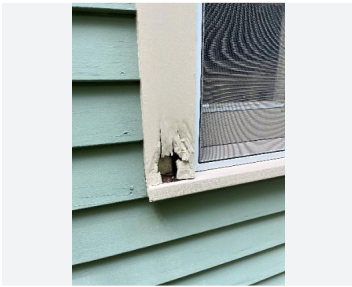
Location - Eastside wall

The exterior window trim shows signs of rot, which can lead to further deterioration and potential moisture intrusion. It's important to repair or replace the affected trim to prevent damage to the underlying structure. I recommend consulting a qualified contractor for evaluation and repairs. Regular maintenance will help extend the life of the windows.

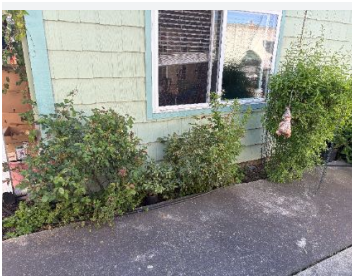
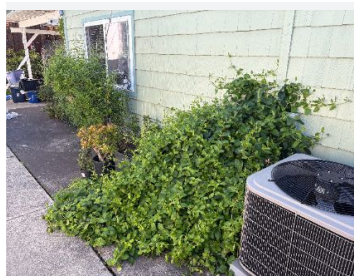
The vegetation is observed to be too close to the building, which can lead to moisture retention, pest intrusion, and potential damage to the siding or foundation. It is recommended to trim back or remove plants to maintain at least 12-18 inches of clearance from the exterior walls. This will help improve air circulation, reduce moisture buildup, and minimize pest risks. Reassess the plant growth periodically to ensure compliance with safe clearance distances.

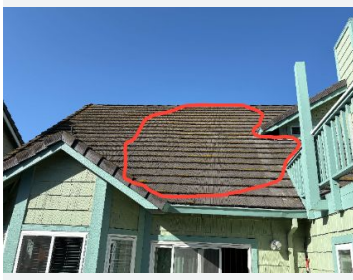
During the inspection, mold growth was observed on the roof. This indicates moisture buildup, which could lead to structural damage if not addressed promptly. It's recommended to conduct a thorough cleaning and inspect for potential sources of moisture. Consider consulting a professional roofer or mold remediation specialist to assess and rectify the underlying issue to prevent further damage. Regular maintenance and improved ventilation may also help in preventing future mold growth.

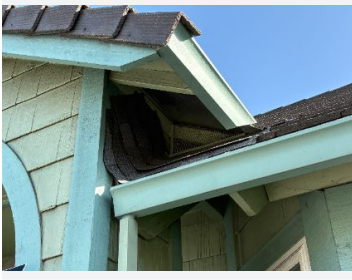
Valley area leaks

During the inspection, active leaks were observed in the roof valleys. These issues can lead to significant water damage and should be addressed promptly. I recommend having a licensed roofing contractor evaluate and repair the affected areas to prevent further deterioration and ensure proper water drainage. Regular maintenance checks can also help in early detection and prevention of future leaks.

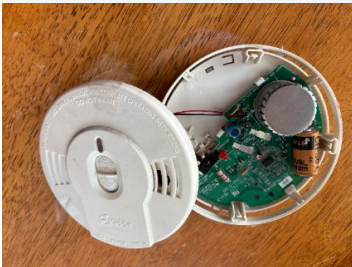
#### Smoke Detector Missing or Out of Order

During the inspection, it was noted that the smoke detector was hanging loose in the kitchen and has no battery. It is vital to ensure the presence and proper operation of smoke detectors for early fire detection and safety. I recommend immediate replacement or repair of any non-operational units and installation where missing. Regular testing and maintenance, as per manufacturer guidelines, are essential to ensure ongoing functionality. Safety code requires installing smoke detectors outside each sleeping area, and on every level of the home.

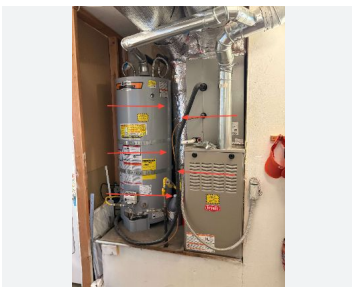
The heating and water heating systems at 3668 El Grande Drive, San Jose, CA, exhibit several major defects that require immediate attention. The furnace (Bryant model) and water heater (ProLine model) are installed in close proximity within a confined utility space, compromising the availability of adequate combustion air for both units, which poses a significant safety hazard due to potential carbon monoxide buildup. The temperature-pressure relief (TPR) valve on the water heater is improperly positioned behind the unit, rendering it inaccessible for maintenance and unable to function effectively in an emergency. Additionally, the absence of a drip pan beneath the water heater and a discharge pipe for the TPR valve increases the risk of water damage and scalding hazards. These critical issues necessitate immediate relocation of the units to ensure proper spacing and combustion air, installation of a drip pan, and correction of the TPR valve setup with a properly routed discharge pipe to comply with safety standards.

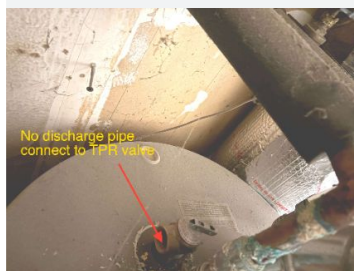
The water heater lacks a drip pan and TPR (Temperature Pressure Relief) discharge pipe. These components are essential for preventing water damage and safely controlling excess pressure and temperature. It is recommended to have a qualified plumber install a drip pan and TPR discharge pipe to meet safety standards and prevent potential hazards.

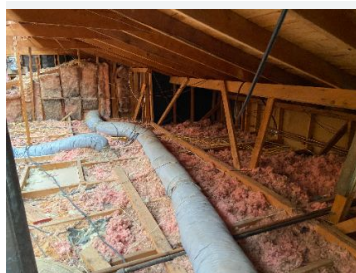
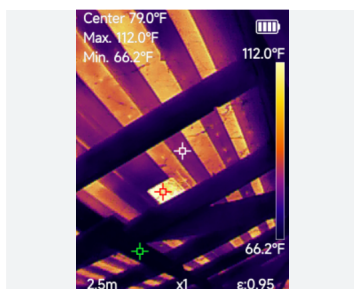
During the inspection of the attic insulation, cellular insulation was observed to be thin and unevenly distributed, with some areas having barely any coverage. Thermal imaging indicates significant energy loss in these sections. It is recommended to enhance the insulation to improve energy efficiency. A professional insulation contractor should be consulted to assess and properly address these deficiencies, ensuring even and sufficient coverage throughout the attic space.

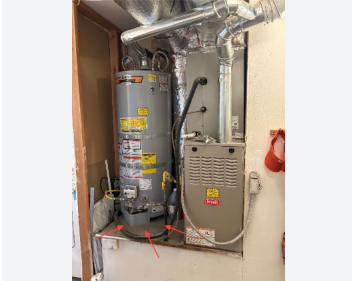
During inspection, it was noted that the furnace is located too close to the water heater. Both appliances require adequate combustion air to function safely and efficiently. Additionally, they should not share the same exhaust vent system, as this can lead to backdrafting and potential exposure to harmful gases. It is recommended to consult a licensed HVAC professional to assess the setup and make necessary adjustments to ensure compliance with safety standards and to prevent any hazardous conditions.

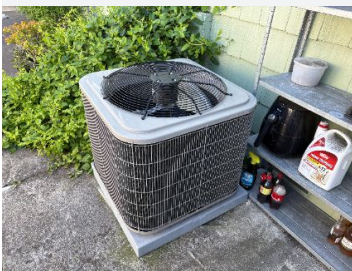
The air conditioning unit operates normally; however, it is surrounded by vegetation, which can impede airflow and reduce efficiency. It is recommended to trim back any nearby plants and ensure there is at least two feet of clear space around the unit. This will help maintain optimal performance and extend the unit's lifespan. Regular maintenance and clearing of debris is advised to prevent future issues.

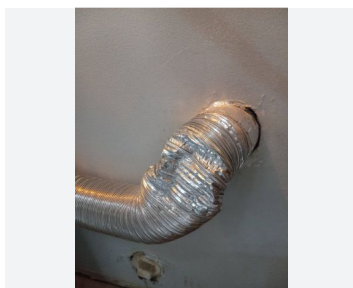
During the inspection, the dryer exhaust hose was found to be crushed. This can restrict airflow, potentially leading to inefficient dryer operation, longer drying times, and an increased risk of overheating or fire. It is recommended to replace the damaged hose with a rigid or semi-rigid duct to ensure proper ventilation and enhance safety. Regularly inspecting and cleaning the vent system is also advised to maintain optimal dryer performance.
