Apr 30th, 2025

302 Prairie View Court, San Jose, CA 95127

# Home Inspection Report

Caleb Zhang / Nextgen Home Inspections,  
LLC

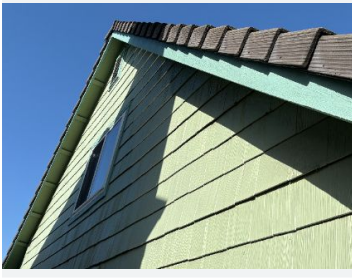
##### Exterior Siding

The exterior siding appears to be in generally good condition, with no major defects noted upon visual inspection. Routine maintenance, such as cleaning and sealing, is recommended to prolong its lifespan and maintain aesthetic appeal. Address any minor gaps or damage observed to prevent water intrusion.

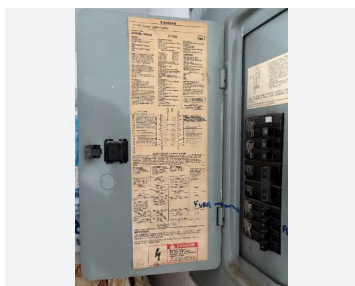
**LOCATION:** Inside the converted garage

#### Main panel labels unclear

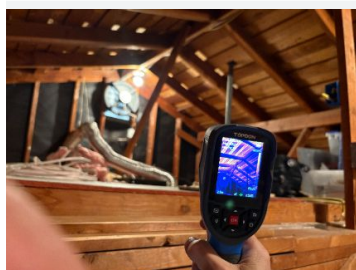
**INFORMATION:** The attic is equipped with a ventilation fan designed to expel hot air; however, this setup may generate negative airflow, potentially drawing in unconditioned air or moisture. The ideal attic ventilation system would feature cool air entering through the soffit vents and hot air exiting via a ridge vent, promoting balanced airflow and preventing moisture buildup or structural damage.

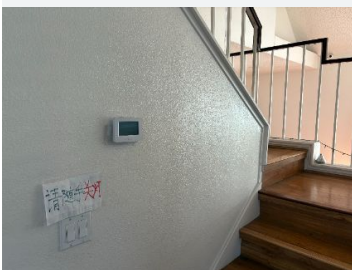
INFORMATION: Thermostat was located on the wall near stairs

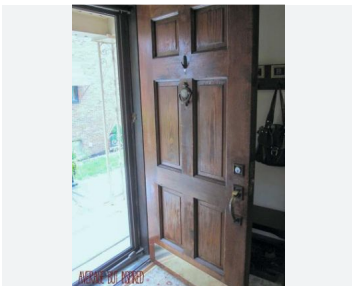
Location - Southwest

The front exterior door shows significant signs of weathering, with noticeable sun damage, cracks, and faded paint. Additionally, both the door seal and weatherstrip are broken or damaged. It is recommended to sand and repaint the door to restore its appearance and protect it from further weather damage. Also, replacing the seal and weatherstrip will ensure optimal energy efficiency and weather resistance. Consider consulting a professional for these repairs to maintain the door's integrity and functionality.

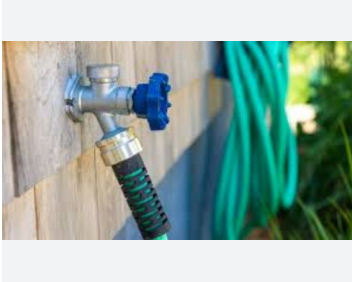
Location - Southwest

The exterior hose bib was observed to be dripping water, which can lead to water wastage and potential damage to surrounding areas. It's recommended to have the hose bib inspected and repaired by a qualified plumber to prevent further leakage and ensure efficient water use.

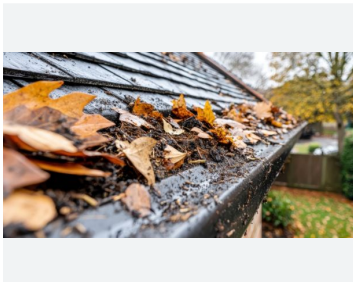
Location - Along all eaves

Need cleaning

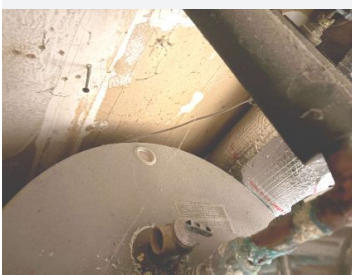
Location - Behind the heater exhaust

During the inspection, it was noted that the Pressure Temperature Relief (PTR) valve on the water heater has limited access, which can hinder regular maintenance and safety checks. Additionally, there is no discharge pipe attached to the PTR valve. It is recommended to have a qualified plumber evaluate and address these issues to ensure compliance with safety standards and proper functioning of the water heater system.

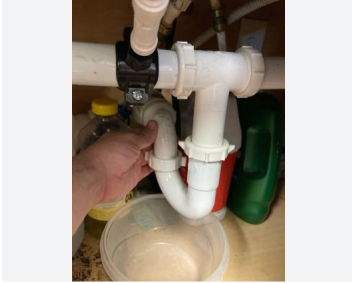
Location - Under kitchen sink

During the inspection of the kitchen plumbing/fixtures, a leak was observed at the P-trap beneath the sink. This issue can lead to water damage or mold if not addressed promptly. It is recommended to have a licensed plumber evaluate and repair the P-trap to prevent further complications. Regular maintenance is advised to ensure the plumbing system remains in good condition.

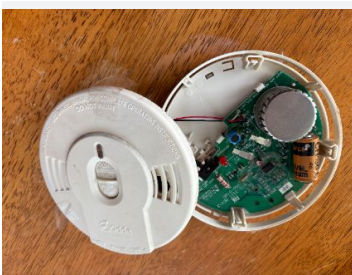
Location - Should be at the kitchen ceiling

During the inspection, it was noted that the smoke detector is either missing or not operational. This is a significant safety concern, as functional smoke detectors are crucial for early fire detection and occupant safety. It is recommended to install and/or replace smoke detectors immediately. Ensure they are positioned according to local codes and test them regularly to confirm proper operation. Consider using detectors with a 10-year lithium battery or those integrated into a monitoring system for enhanced safety.
